**Transport Safety Investigation Bureau
Safety Flyer – 2019/1**

Use of appropriate fairleads for mooring

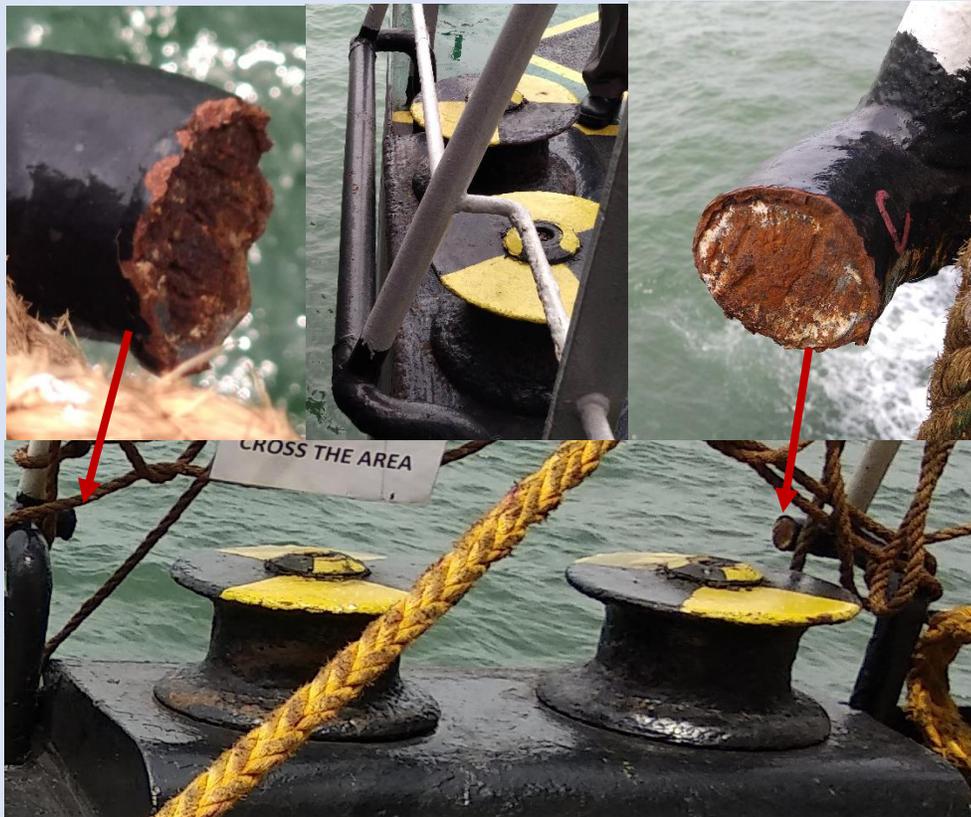
3. In a recent incident during bunkering operations when a bunker tanker was supplying bunkers to a container vessel at the berth, one of the bunker tanker's stern mooring rope jumped off (whiplash) from the open fairlead in an upward direction. This was due to the railing (referred to as a "stopper bar" by the ship and company), directly above the roller fairlead, breaking from the welded seams.

4. Closer inspection conducted on board the bunker tanker revealed some safety concerns -
 - a. The "stopper bar" was a part of the ship's railing and not a part of mooring fitting. (See **figure 1**)

Figure 1: The sheared off “stopper bar” above the roller fairleads

5. The company involved had changed all mooring fittings on the vessel to the universal type after the occurrence.

6. Mooring lines should only be led through closed fairleads (referred to as universal fairleads) suitable for STS operations. The use of stopper bars to retrofit open fairleads is not recommended as they are not designed or tested to withstand mooring loads.
7. Each ship should be provided with information on the design of the mooring system (including proper fittings/fairleads to be used for mooring) with examples to show the loads likely to be experienced under particular conditions and to illustrate those situations under which the limit of the system is likely to be reached.
8. Ship's crew should always be aware of the lead of the mooring lines that could be expected during the operation and highlight the hazards to the company so that appropriate risk mitigating measures can be implemented timely.

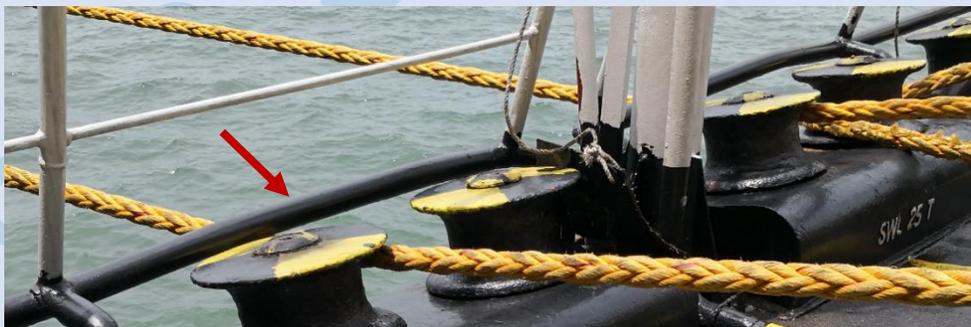
- b. There were no records to indicate the strength of this railing which was not designed or tested for mooring purpose. Over the period of the bunker tanker's operational life cycle, this railing had always been wrongly considered by the crew as a part of the mooring fitting during STS bunkering operations. The mooring lines usually had an upward lead and this had likely caused strain on the railing over time. (See **figure 2**)

Figure 2: Arrow showing the bent railing above the roller fairleads at the aft mooring station
