**Harbor Safety Committee Recommendation: San Francisco PORTS**

**Report From the PORTS Work Group on the Cosco Busan Incident and San Francisco PORTS**

### **Ferry Operations Work Group Recommendations to the Harbor Safety Committee:**

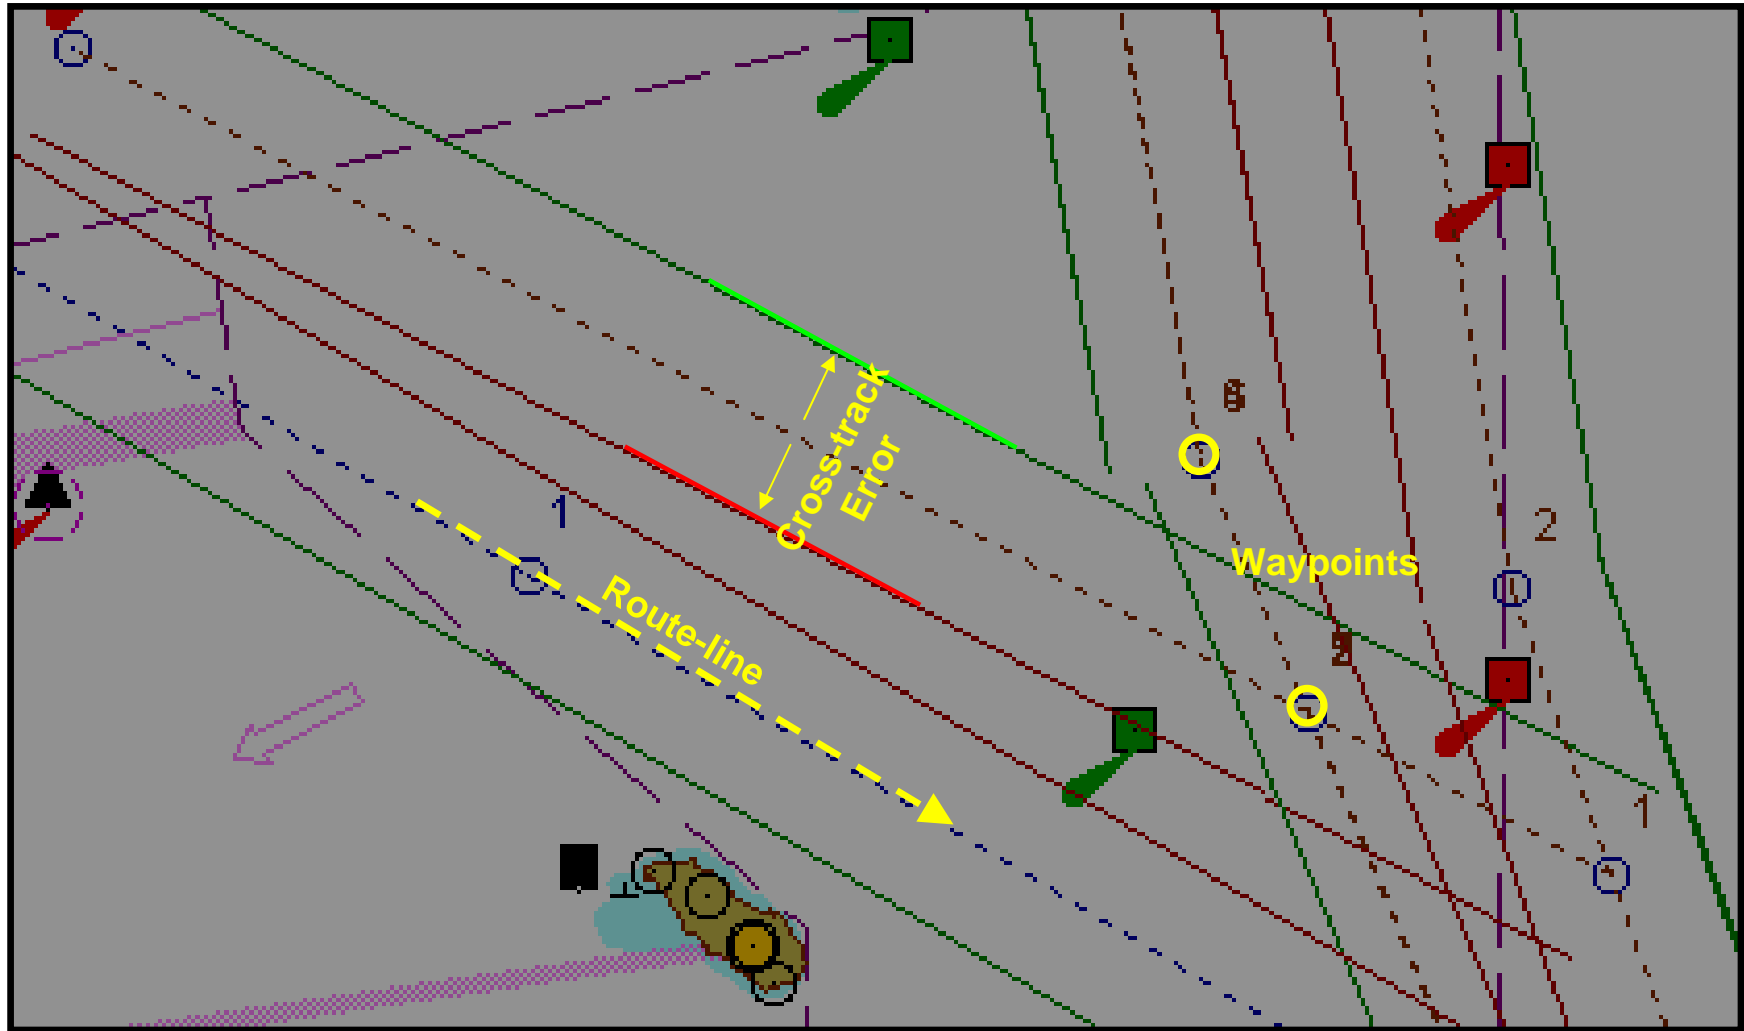
# Diagram Key

The following chart features are highlighted above.

- Route-line: Centerline of the ferry route.
- Cross-track Error: Left and right of route-line tolerance.
- Waypoints: Turns, route crossing points, and communications points.

Diagrams are screen print files from vector-based electronic nautical charts (ENCs).
